Evaluation of Potential Use of Vegetation for Erosion Abatement Along the Great Lakes Shoreline

by
V.L. Hall and J.D. Ludwig

MISCELLANEOUS PAPER NO. 7-75
JUNE 1975

Prepared for
**U.S. ARMY, CORPS OF ENGINEERS
COASTAL ENGINEERING
RESEARCH CENTER**

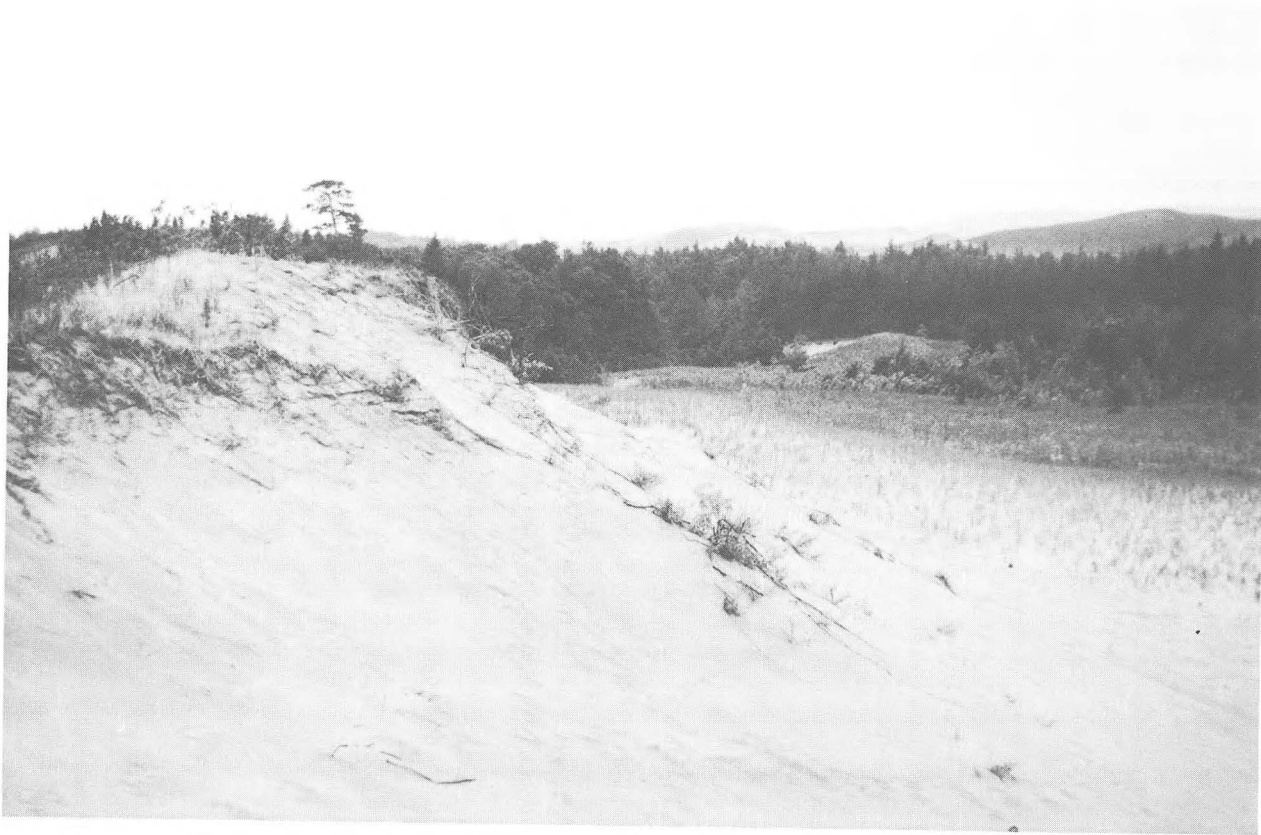
Sand dunes of the Grand Sable Banks near Grand Marais, Michigan, are subject to blowouts (Fig. 2) and wind erosion. The shore at Whitefish Point, Michigan, is relatively flat and is eroding. Rock was exposed in many areas, but where vegetation existed, it retained small mounds of sand; this area showed some of the most successful examples of sand retention by vegetation.

Figure 2. Sand blowout caused by wind erosion.

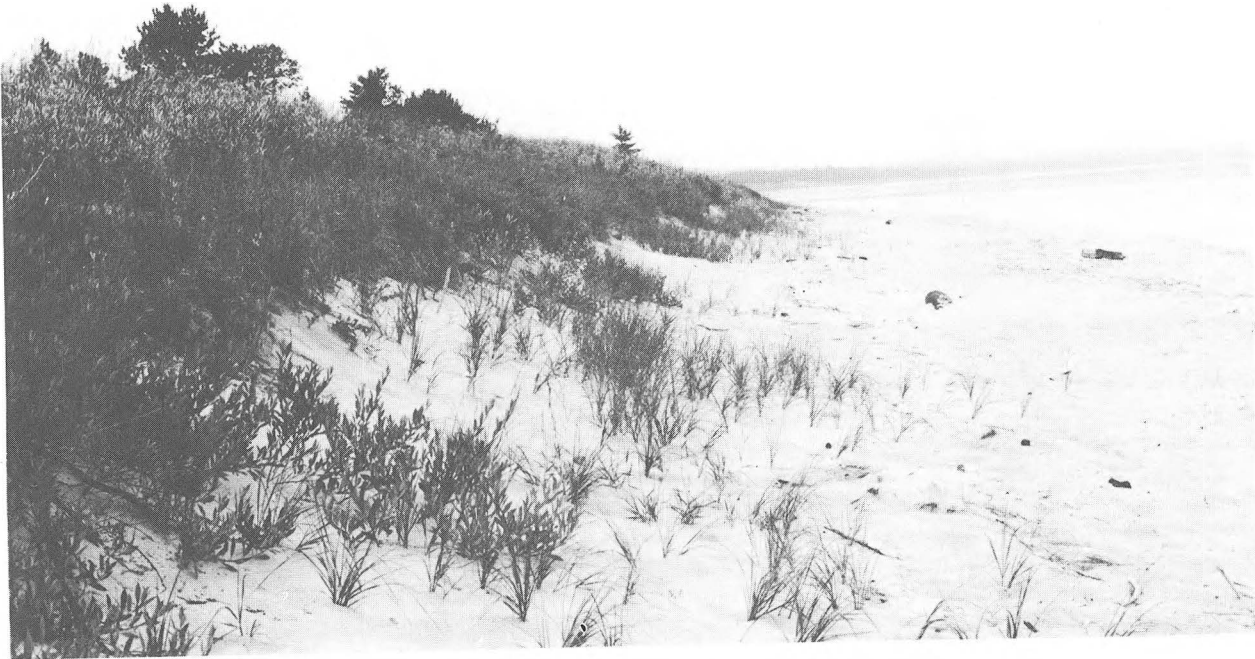
Eleven miles west of Munising, Michigan, is a sandy shore stabilized by wild rye and sand cherry (*Prunus pumila*). Invasion of the secondary colonizer, sand cherry, is successfully stabilizing the soil (Fig. 3). Active sand dune blowouts, stable sand dunes, and successional plant establishment were found at Grand Marais State Park, Michigan. Pioneer sand stabilizer was again wild rye. The lee side of active dunes was colonized by the herbaceous pioneer tansy (*Tanacetum huronense*) and the secondary colonizers sand cherry and heart-leaved willow (*Salix cordata*). Tertiary species were limited to balsam poplar (*Populus balsamifera*). At Whitefish Point, Michigan, abrasion by blowing sand limited vegetative vitality and diversity, although the low-habit false heather (*Hudsonia tomentosa*), along with scouring rush (*Equisetum hyemale*) and wild rye, were vigorous enough to impede the wind and accumulate appreciable sand mounds.

Figure 3. A secondary colonizer, sand cherry, invading a sand dune moderately stabilized by wild rye.

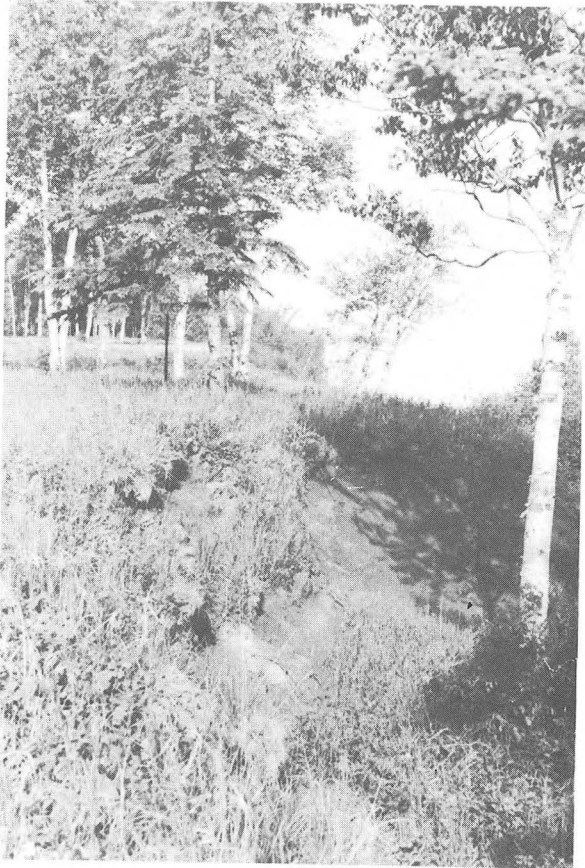
Some bank erosion along the Lake Superior shore was caused by seepage (Fig. 4) and wave scouring (Fig. 5). Only one structure was noted, riprap to abate bank erosion near the State highway at Herbster, Wisconsin. The treatment appeared successful; the bank was stabilized, with vegetation well established between the riprap and road to prevent erosion due to surface runoff.

Figure 4. Bank erosion caused by seepage high above the water level (left). Wave action on toe of slope (right) accelerates soil movement down the bank.

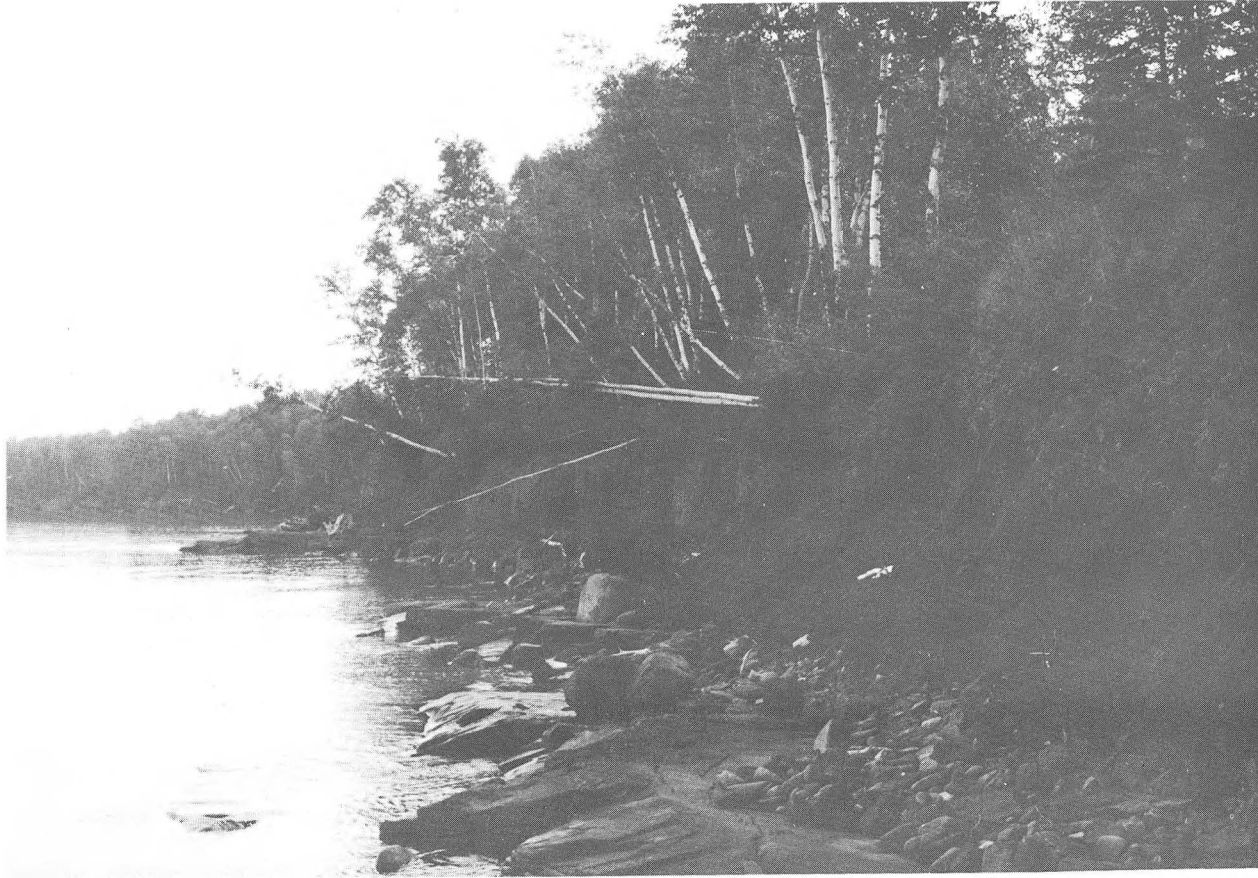
Figure 5. Wave scouring causes undercutting and bank recession with loss of vegetation.

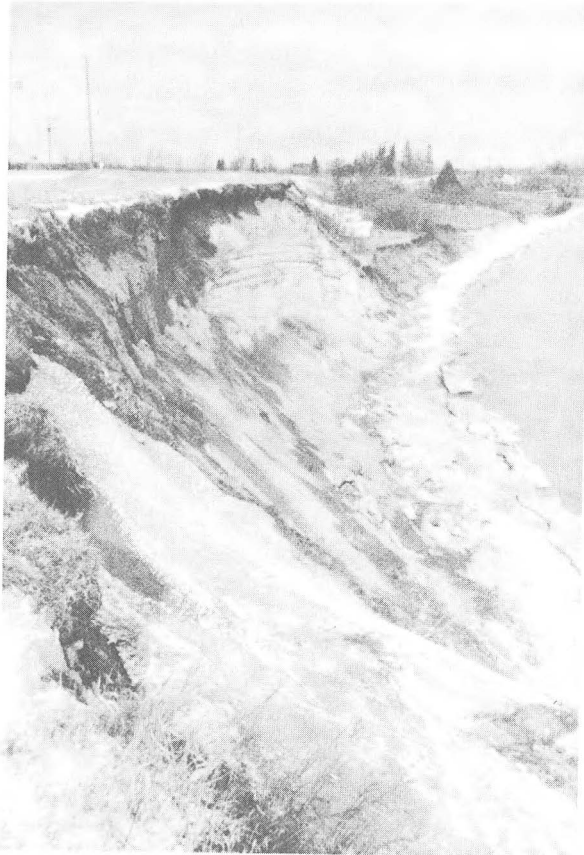
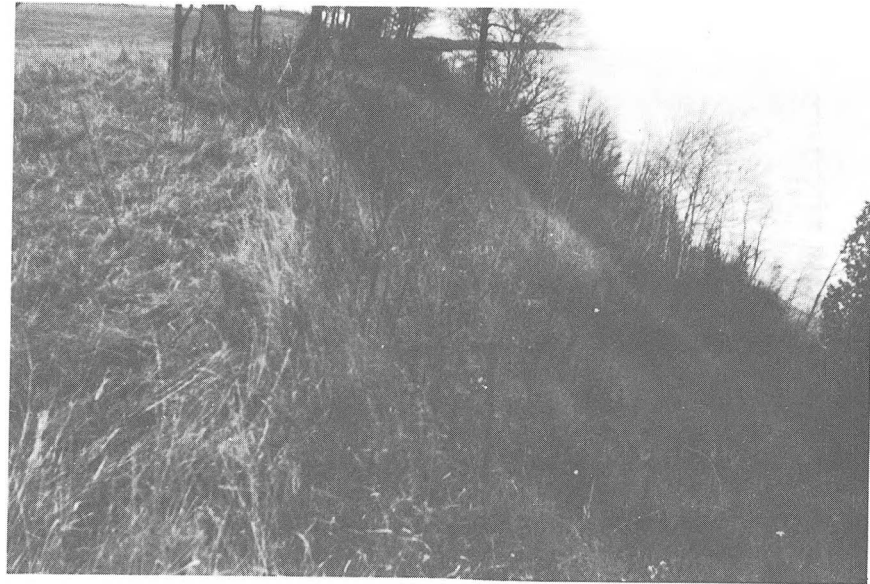
Kewaunee County shores south of Kewaunee, Wisconsin, were high, near-vertical bluffs of glacial till with exposed sand and gravel lenses. During wet periods, the lenses become water-saturated and seepage along

the bluff causes slumping of the soil and, at times, large landslides.

The Soil Conservation Service at Kewaunee, Wisconsin, has successfully stabilized shores by dewatering the glacial till, sloping the face of the bluffs, and seeding the reshaped slopes (Fig. 6). In this case, dewatering is the key factor and is essential to control erosion caused by seepage.

Figure 6. Lake Michigan bank erosion caused by seepage through sand and gravel layers in the glacial till (left). Dewatering, bank reshaping, and seeding to prevent erosion by runoff has stabilized bank recession (above). (Courtesy of Soil Conservation Service.)

Land alteration has proved essential for controlling shore and bank erosion in many areas of the Great Lakes. Near Kewaunee, Wisconsin, for example, seepage contributes to bank failure along Lake Michigan. The Soil Conservation Service has successfully installed a deep tile line to intercept seepage and conduct the underground water to Lake Michigan. The banks were reshaped to an approximate slope of 2:1 and the soil was seeded with a mixture of crown vetch and fescue to control surface runoff. Similar dewatering has been effective in urban and rural areas. The work is costly, especially on high banks. In time, if seeding has successfully stabilized soil on the banks, native plant species invade and become established along with planted species.

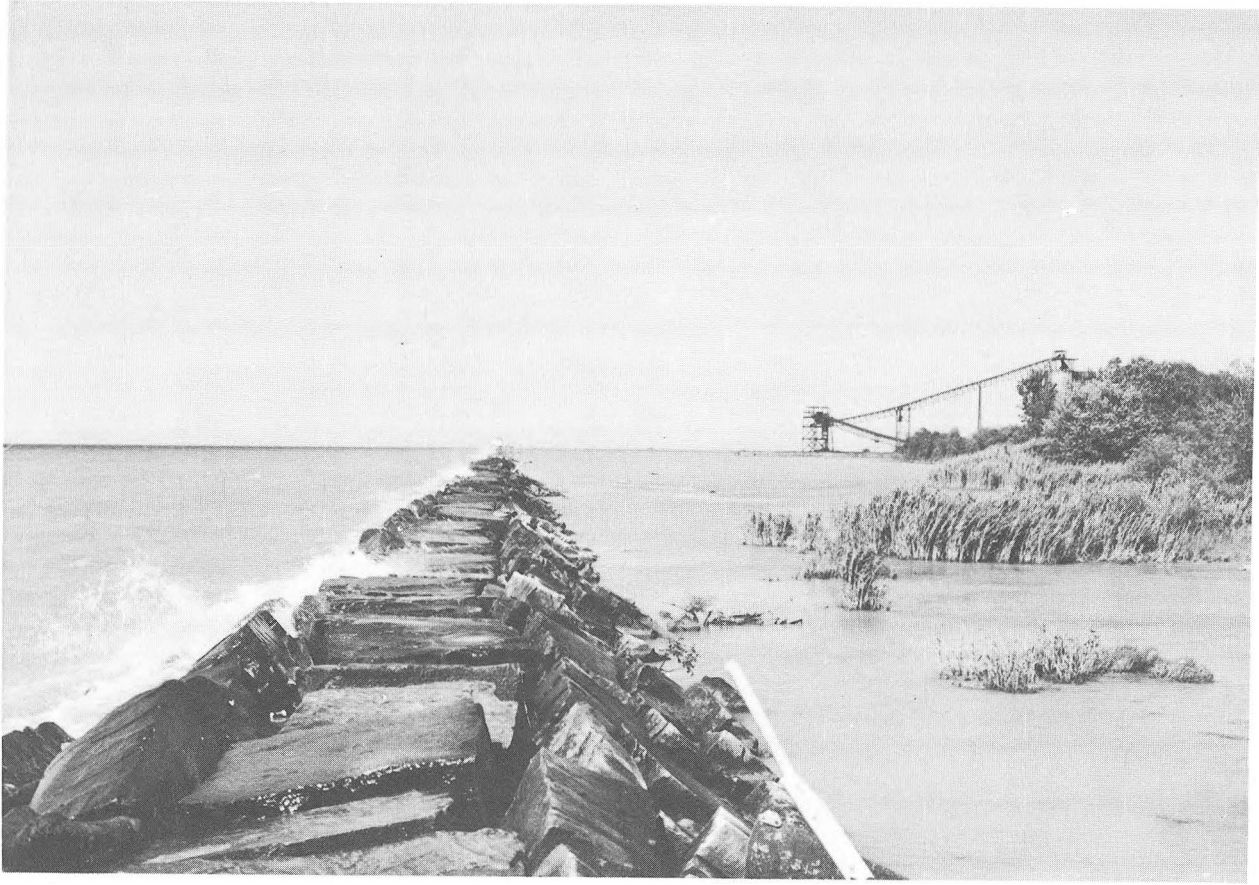
A breakwater jetty at Ashtabula, Ohio, produced a stilling effect between the structure and the shore, providing habitat for reed (Fig. 9).

Figure 9. Protective structure creating pool favorable for growth of reed.

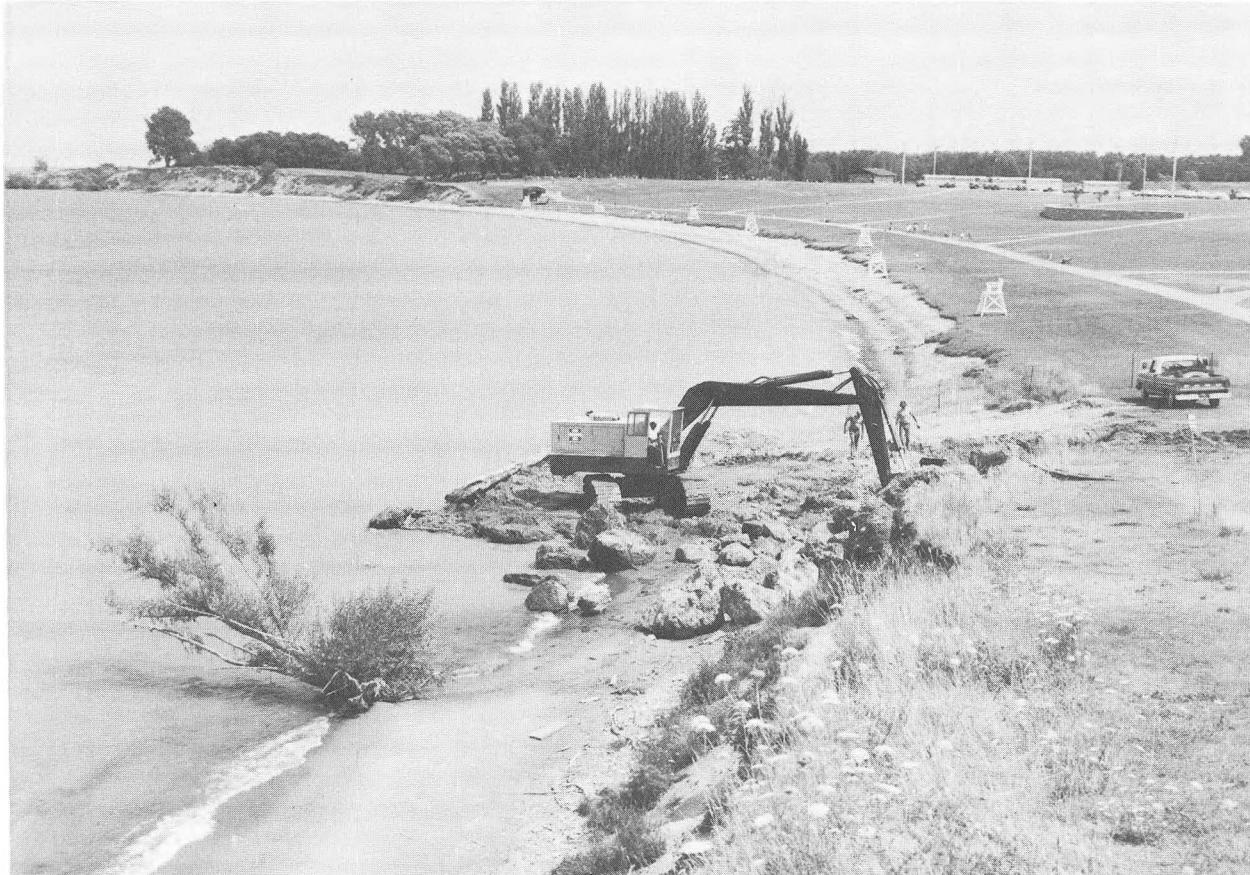
At Hamlin Beach State Park, New York, a high sandbank was graded to a slope of 1:12 (1 unit vertical to 12 units horizontal) and seeded with a grass mixture to stabilize the sand against erosion (Fig. 10). Before reshaping, the sandbank was being eroded by waves; the shore has now stabilized and is a heavily used recreational area.

Figure 10. Landscaped beach area and parking lot developed by reforming a high eroding sandbank.

Reforming and vegetating the beach at Hamlin State Park, New York, on Lake Ontario (Fig. 10) was successful. A high sandbank was reshaped to a 1:12 slope to reduce erosion by dissipating wave energy. The beach and its adjacent recreational area were vegetated to control surface erosion. Since this shoreline modification was for recreation,

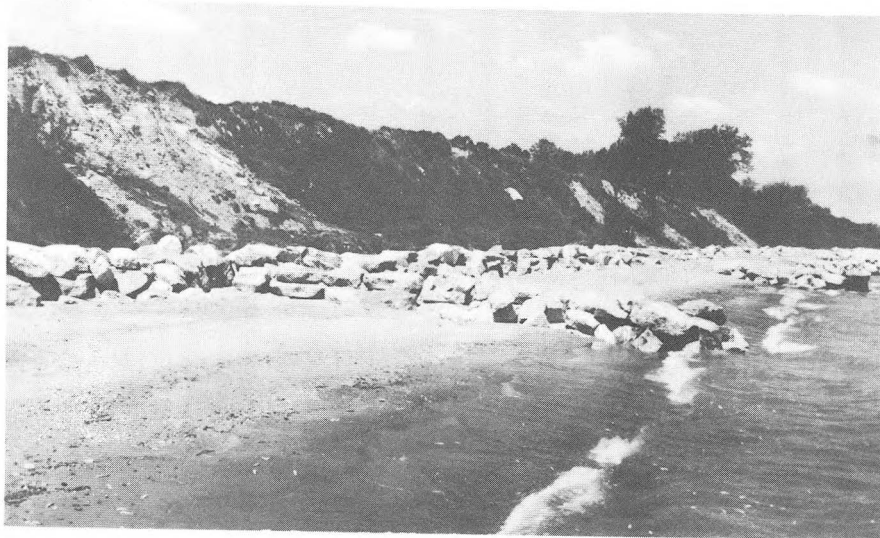
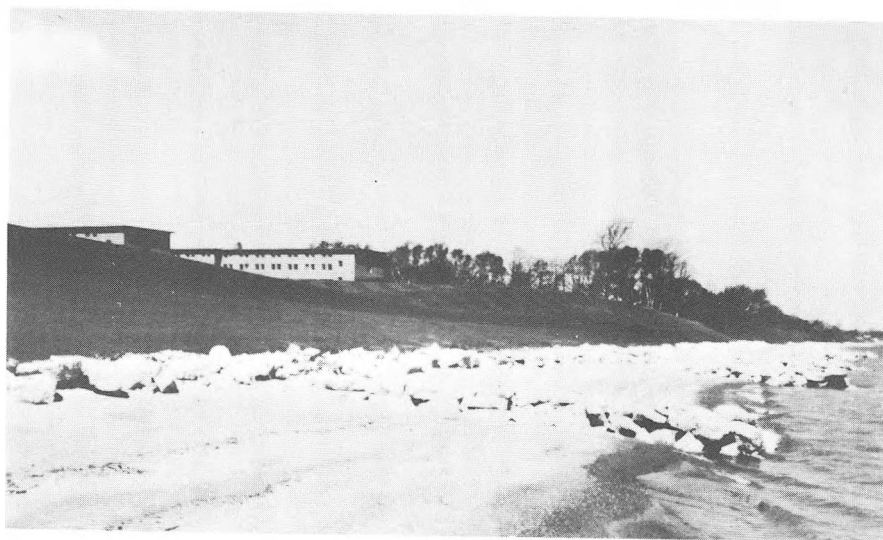
An example of a Lake Michigan shore modification is shown in Figure 11. The site was in Racine County about 3 miles north of Racine, Wisconsin. Rock was used for shoreline protection to minimize erosion of the embankment. The rough steep bank was graded to a more gentle slope and was seeded to control surface erosion. This shore front modification requires a soil that is not subject to seepage so severe that it causes bank failure. Loam soil is best for this type of reclamation. The best vegetative growth is obtained by topdressing with fertilizer and irrigating. Where a specific type of vegetation is desired, weed control may also be required. This shore front renovation requires constant management to maintain a turf appearance.

Figure 11. Reformation of rough bank (above) and landscaping of shoreline (below).
(Courtesy of Soil Conservation Service.)
